Title: LANL Projects to Address the 2017 EM Assessment of Ion Beam Facility

Author(s): Quintana, Vicente M.  
Liechty, Denise Gay

Issued: 2021-06-29

# **LANL Projects to Address the 2017 EM Assessment of Ion Beam Facility**

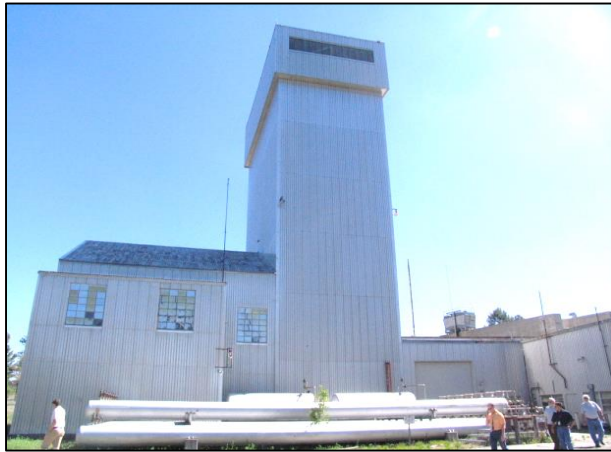
Before Roof Life Extension

**Pg17. Report (“Address the roof in-leakage problem”)**

## Roof Life Extension Project

**\$2M (20 year roof), Completed in FY2019 - funded by Indirect through RAMP**

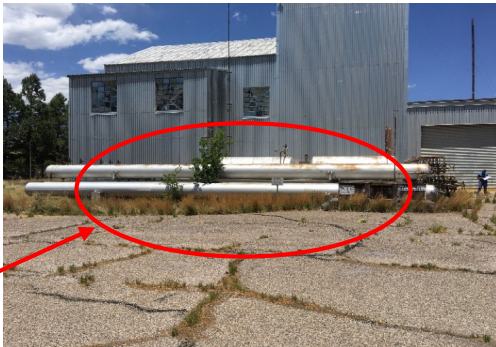
**Pg 17. "NNSA should verify the status of the all the tanks in the tank farm. Verify the tanks are empty ... prior to transfer." Page 20 "Inspect and verify Diesel Tank (03-0191) is empty and Isolated."**

# Ion Beam Tank Farm Removal Project \$331K, Completed FY2019

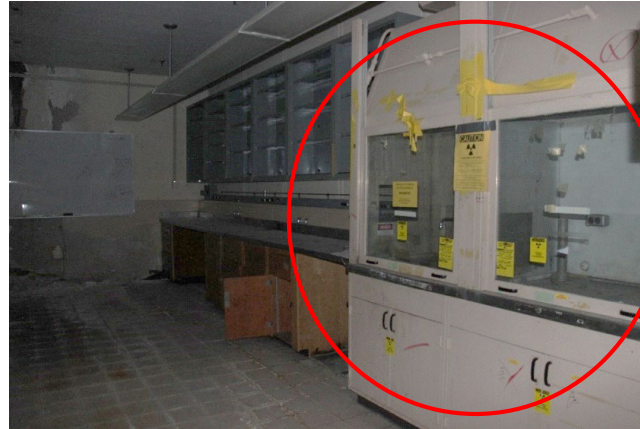
Before

Pg 20. "Ensure the remaining fume hoods, glove boxes, and vent stack openings have sealed covers to prevent inadvertent wafting of airborne tritium that may result from opening of exterior doors or changes in barometric pressure."

## First Floor Laboratory Contaminated Hood and Ducting Removal - Room 120

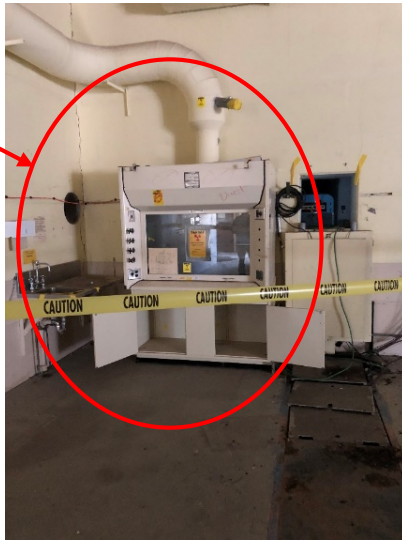
Pg 20. "Ensure the remaining fume hoods, glove boxes, and vent stack openings have sealed covers to prevent inadvertent wafting of airborne tritium that may result from opening of exterior doors or changes in barometric pressure."

## Contaminated Hood and Ducting Removal - Basement

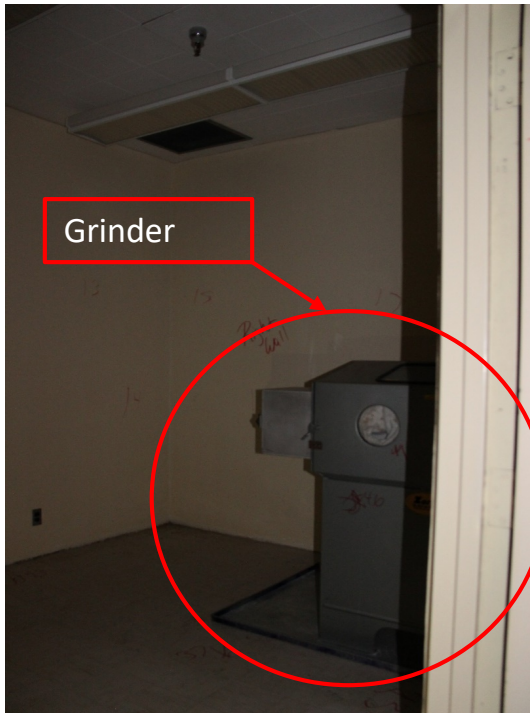
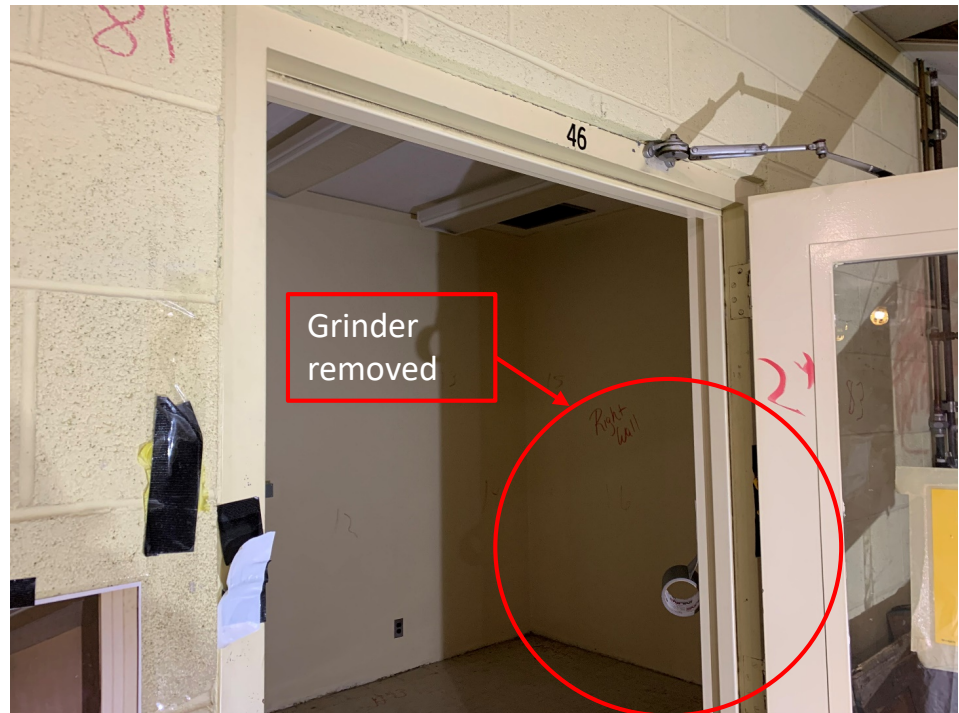
Pg 20. "Ensure the remaining fume hoods, glove boxes, and vent stack openings have sealed covers to prevent inadvertent wafting of airborne tritium that may result from opening of exterior doors or changes in barometric pressure."

## Removal of Grinder – Basement Floor –Room 46

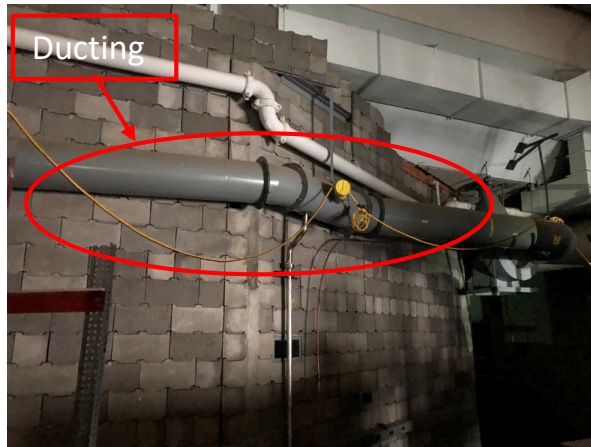
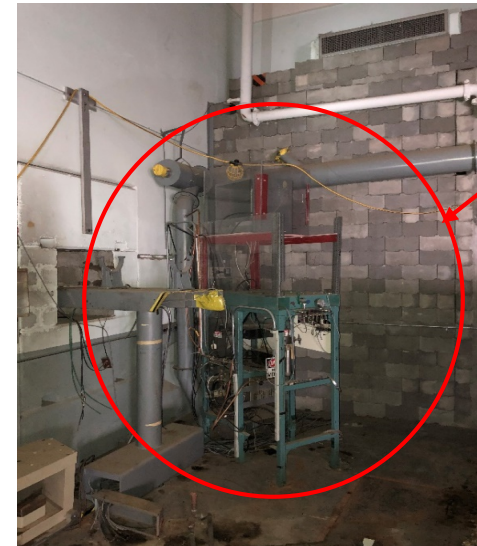
Before

Pg 20. "Ensure the remaining fume hoods, glove boxes, and vent stack openings have sealed covers to prevent inadvertent wafting of airborne tritium that may result from opening of exterior doors or changes in barometric pressure."

## Basement Ducting Removal Adjacent to Horizontal Accelerator
